# BETHEL HIGH SCHOOL BUILDING COMMITTEE

September 22, 2010

## **Bethel High School Building Project Post Facility Report Update**

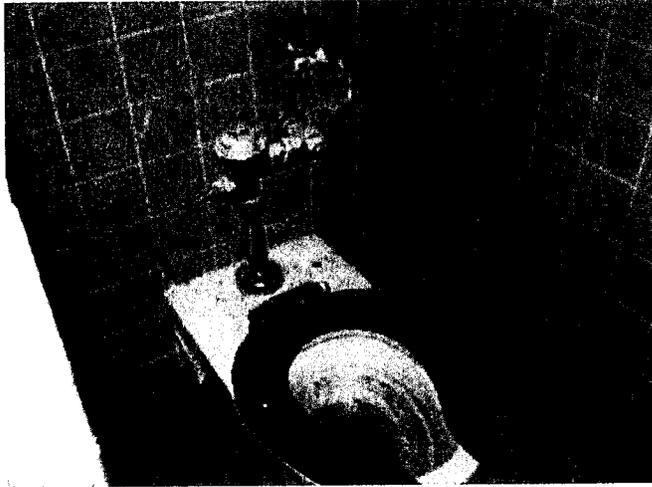
Another typical photo of conditions observed. This was the final product after the new floor tile was installed and room painted. As you can observe the waste lines are dried out in this toilet and entire restroom has holes in concrete as a result from water leaking within the walls. As mentioned, this was part of our confusion, why was paint and tile installed but not plumbing renovations?

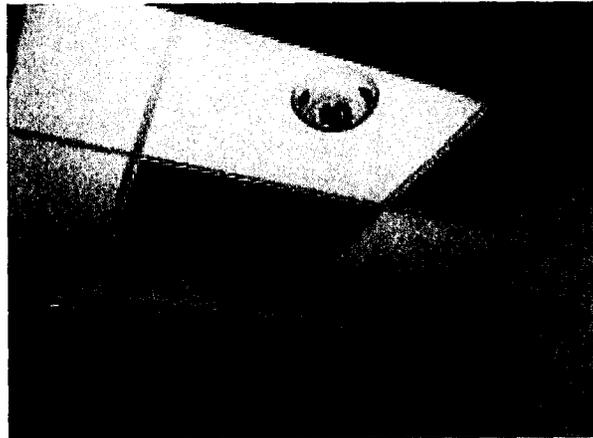
This is an area on the second floor that shows an uncompleted ceiling grid with metal objects hanging from the ceiling above. Numerous areas had unfinished areas that were completed by the custodial staff.
